EASTLEIGH & DISTRICT LOCAL HISTORY SOCIETY

The Bombing of the Railway Works

Paper 67

The Railway Works.

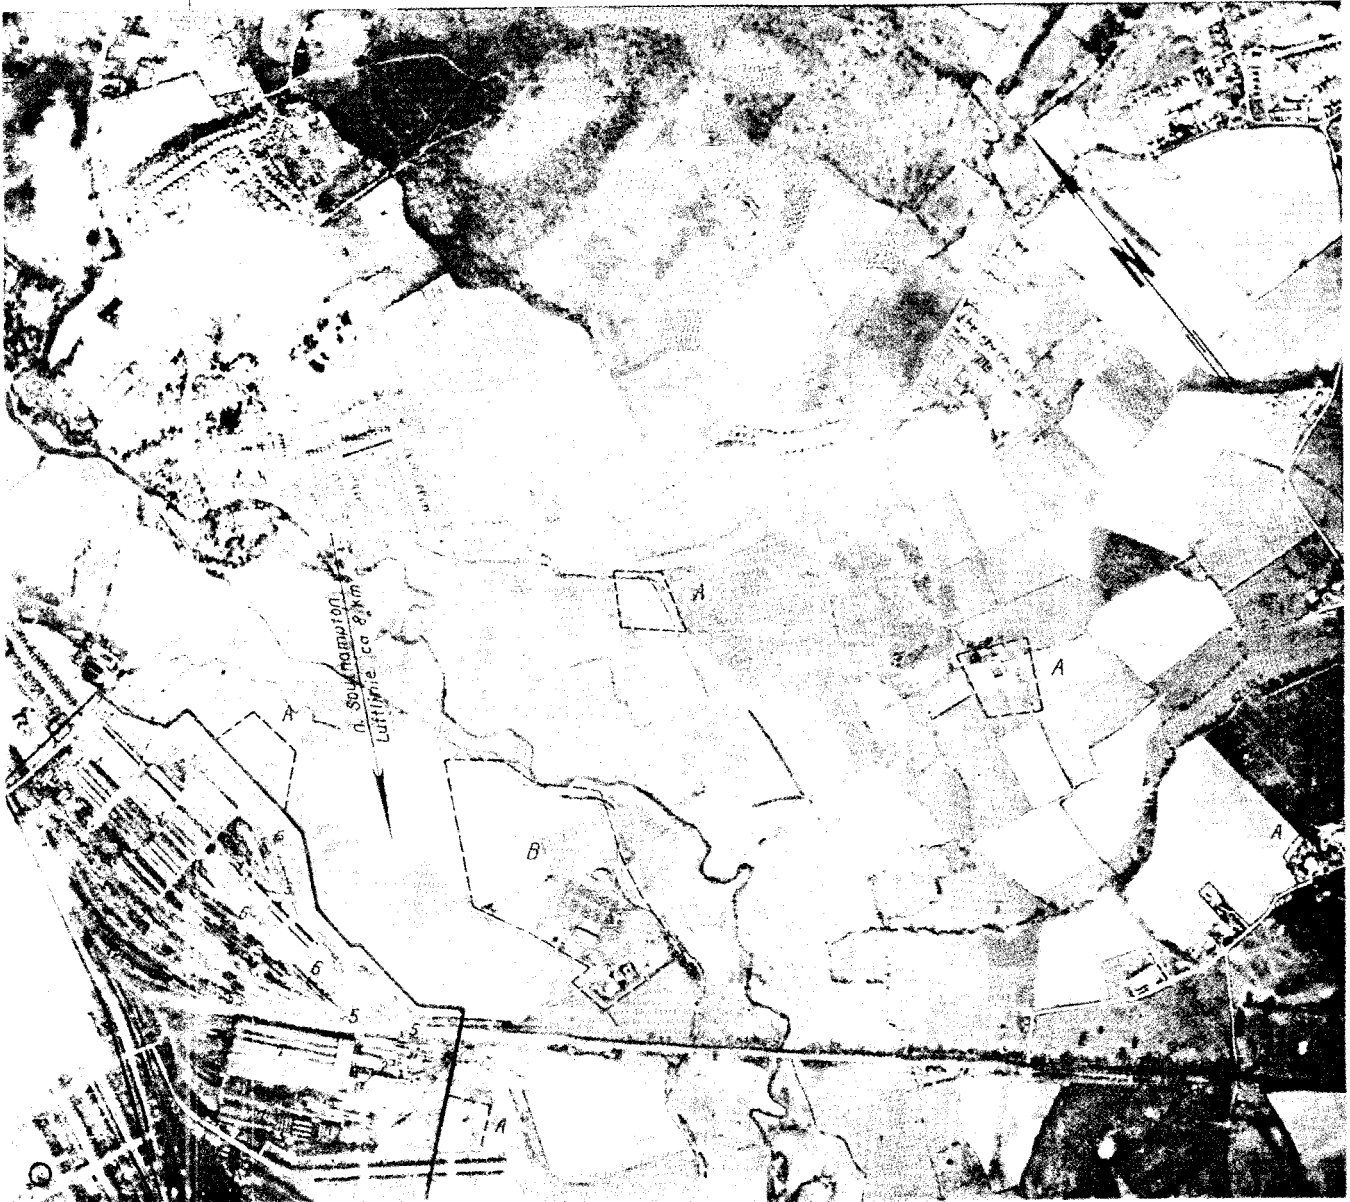
GB 4032 a

1. Werkhallen	etwa	95 000 qm
2. Kessel- und Maschinenhaus	etwa	950 qm
3. Lagerhallen	etwa	7 000 qm
4. Abstellhallen	etwa	4 200 qm
5. Stellwerke	etwa	250 qm
6. Lagerplätze		
7. Verschiebebühne

A Sperrballonaufstiegstellen B Kläranlage

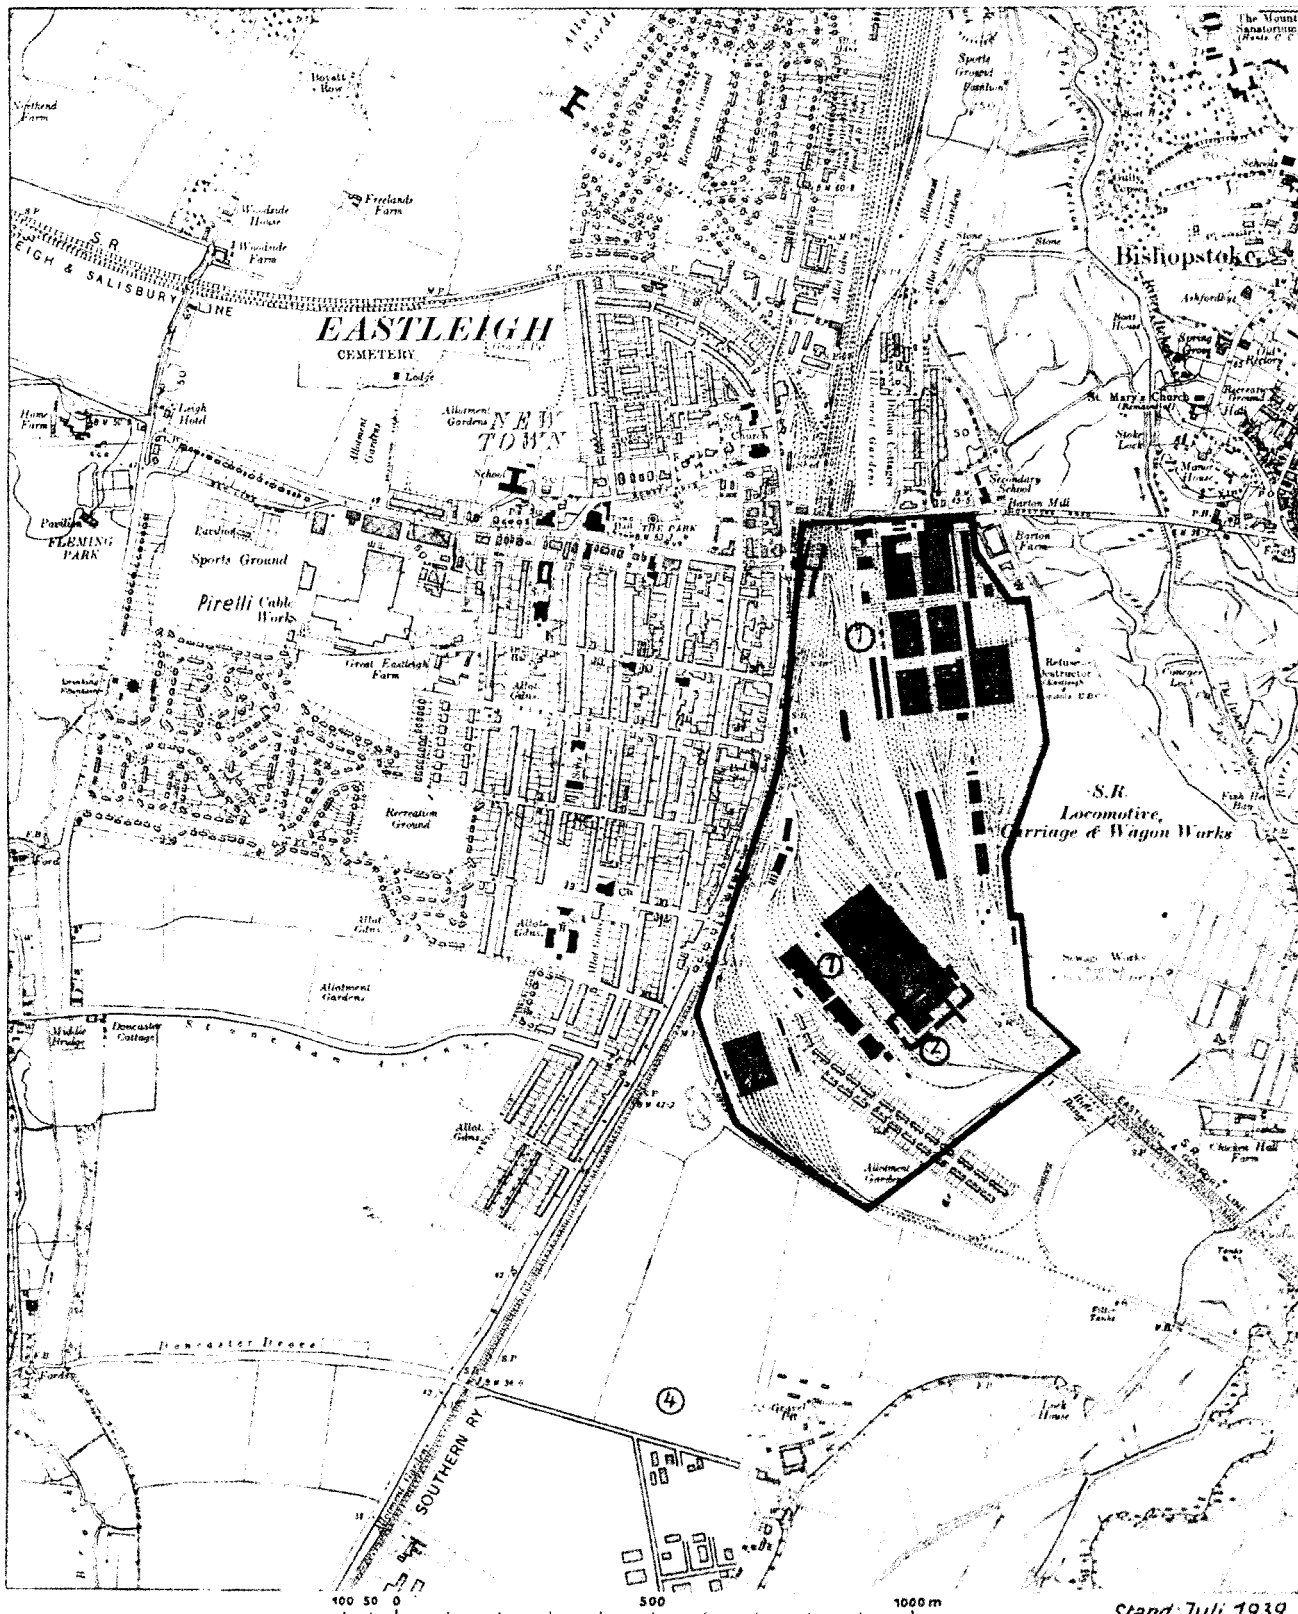
GB 4032 c

1. Werkshallen der S. R.
2. Kessel- u. Maschinenhaus
3. Lokomotivprüfstand
4. Flugplatz Southampton

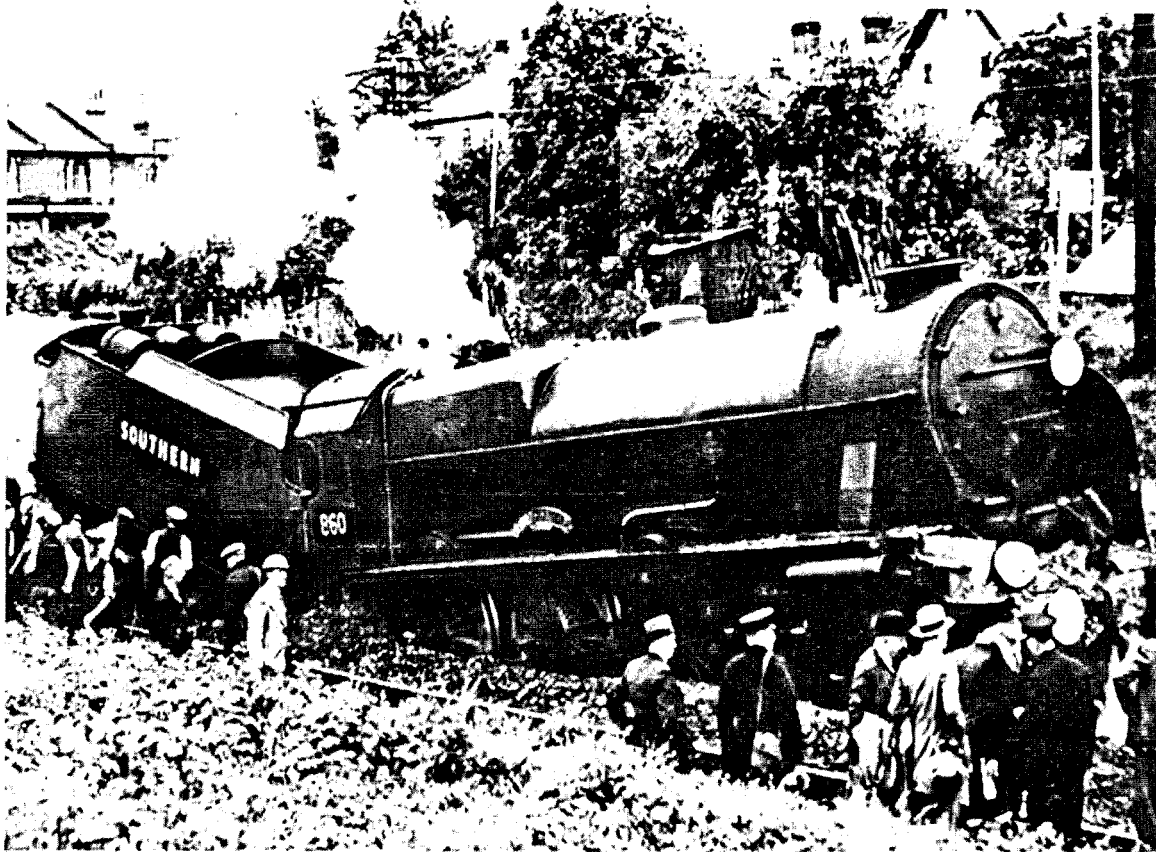
On 14th August 1940 a bomb was dropped on the line just ahead of a locomotive coming towards Eastleigh and it plunged into the crater. Such damage was quickly repaired.

Wednesday 14th August 1940.
Train fell into a bomb-crater on the line at St. Denys.

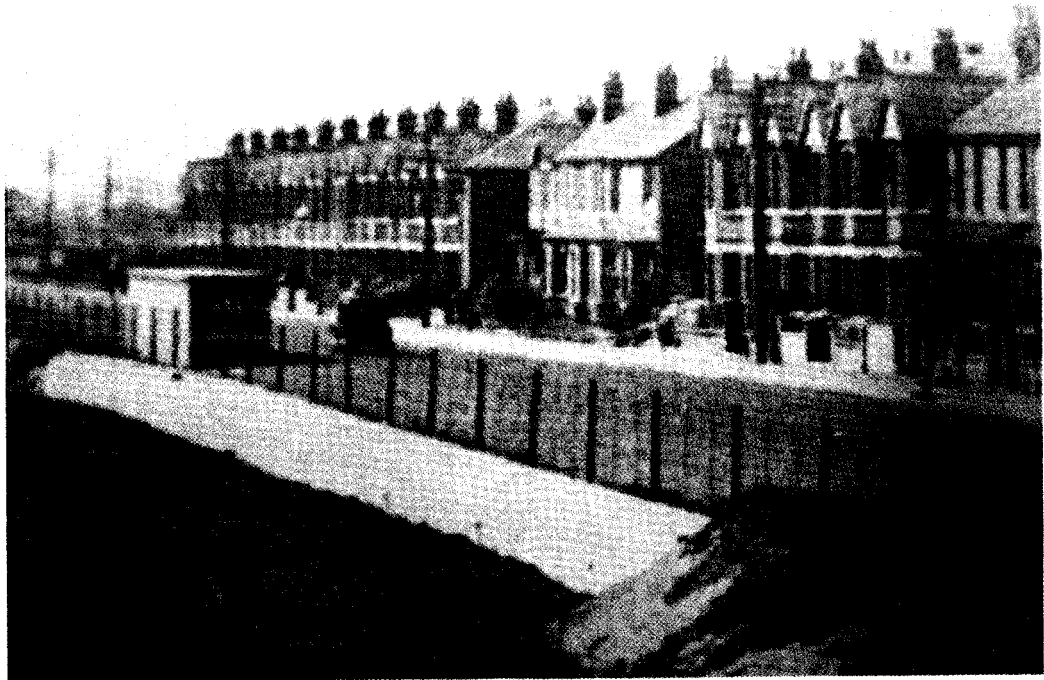
On 19th January 1941, the day the Carriage Works was bombed, Southampton Road and the Railway track alongside were damaged by bombs which destroyed houses at 370 and 372 Southampton Road and a water main was hit. The railway line was back in operation within hours but the road was closed for a month. The gap in the houses just north of York Road was where 370 and 372 Southampton Road had been.

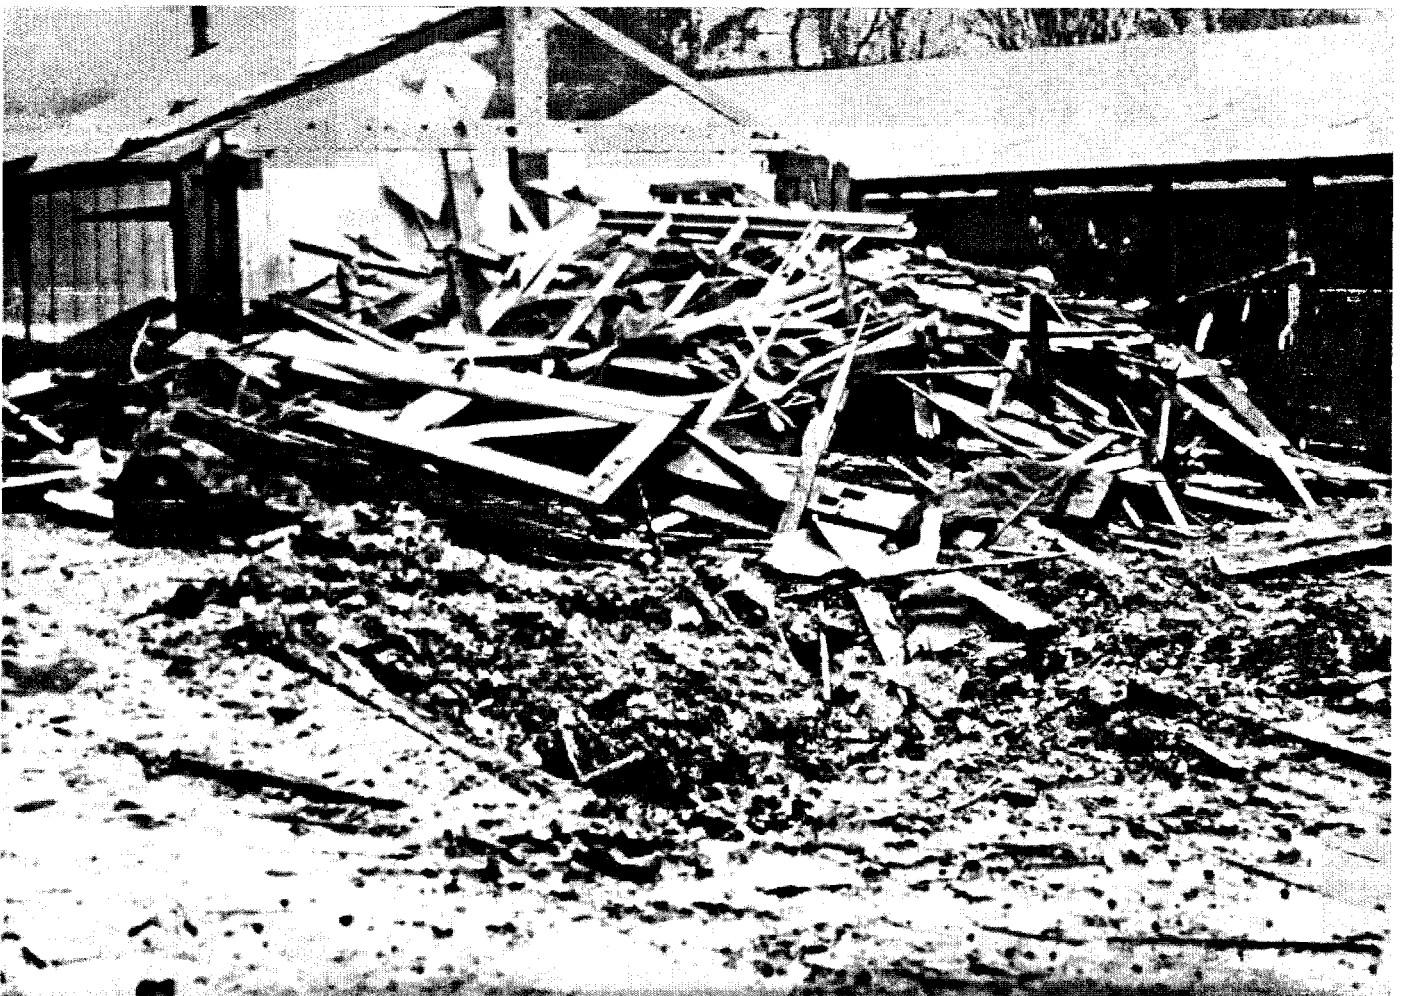
Motor and Cycle Sheds.

A large portion of the Cycle Shed and Motor Car Sheds was demolished by the bomb which fell near these Sheds. This also shattered all the windows on the North side and blew down a number of doors in the Carriage Works General Offices, Stores and Accountants' Offices. The outside staircase to the Accountants' Offices was also damaged. The petrol pump at the Stores gate fired and was rendered useless.

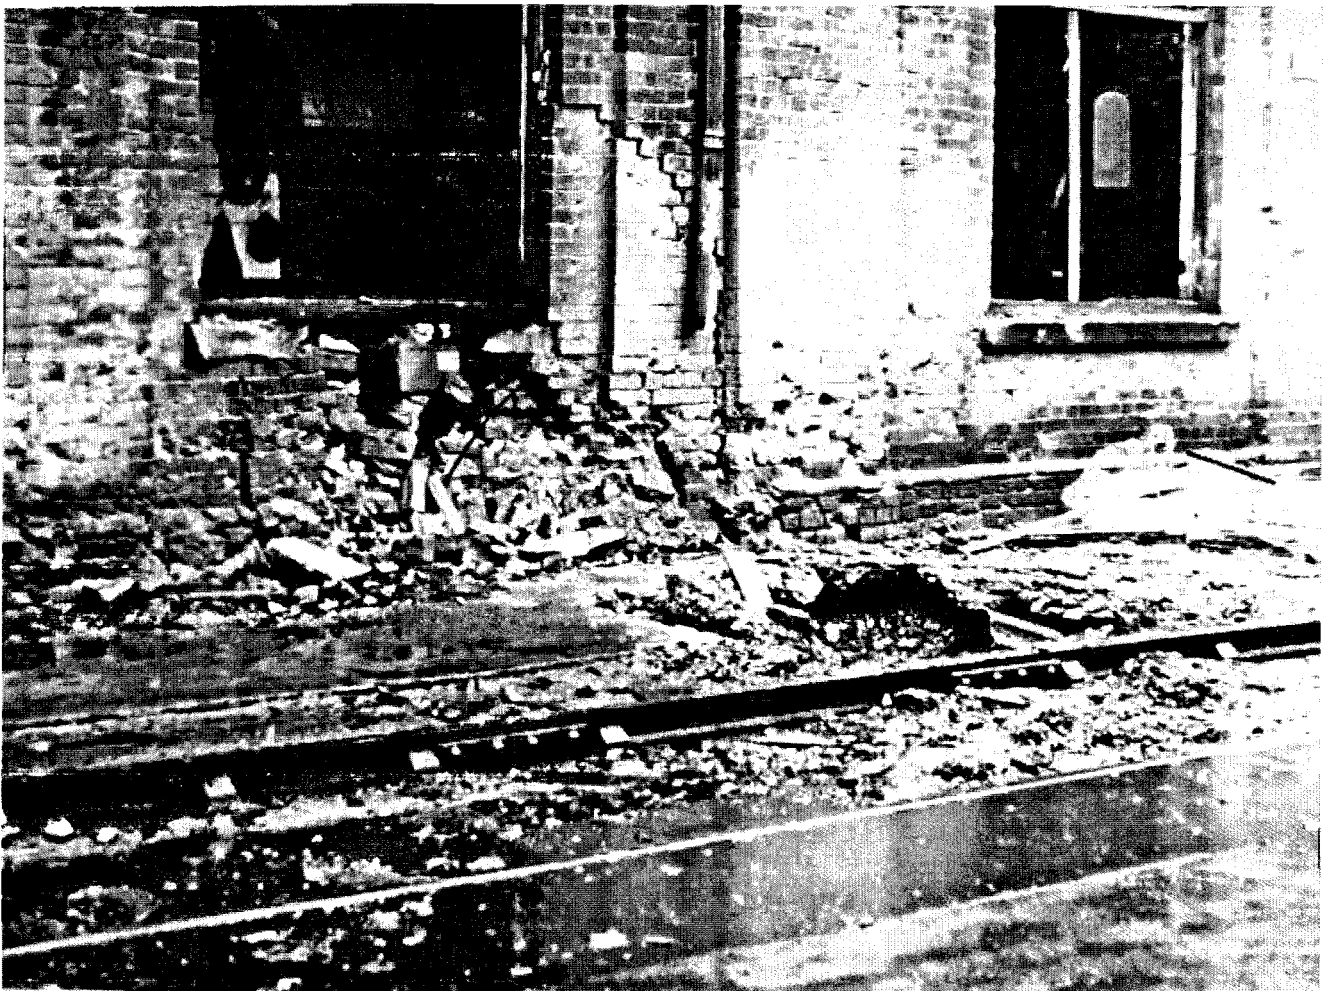
North West Corner of the Carriage Paint Shop.

Paint Shop.

The North West corner of the Paint Shop received damage. A piece of brickwork approximately 10'0" by 4'0" was blown down at ground level. Many windows along the wall and glass in the roof were shattered. A gas main and water main were broken at this point, also the Works clock and clock tower received damage. The windows of the Control Room and Time Offices were shattered. All windows in the South side of General Offices were shattered and a number of doors blown down. Damage was also done to the Ambulance Room.

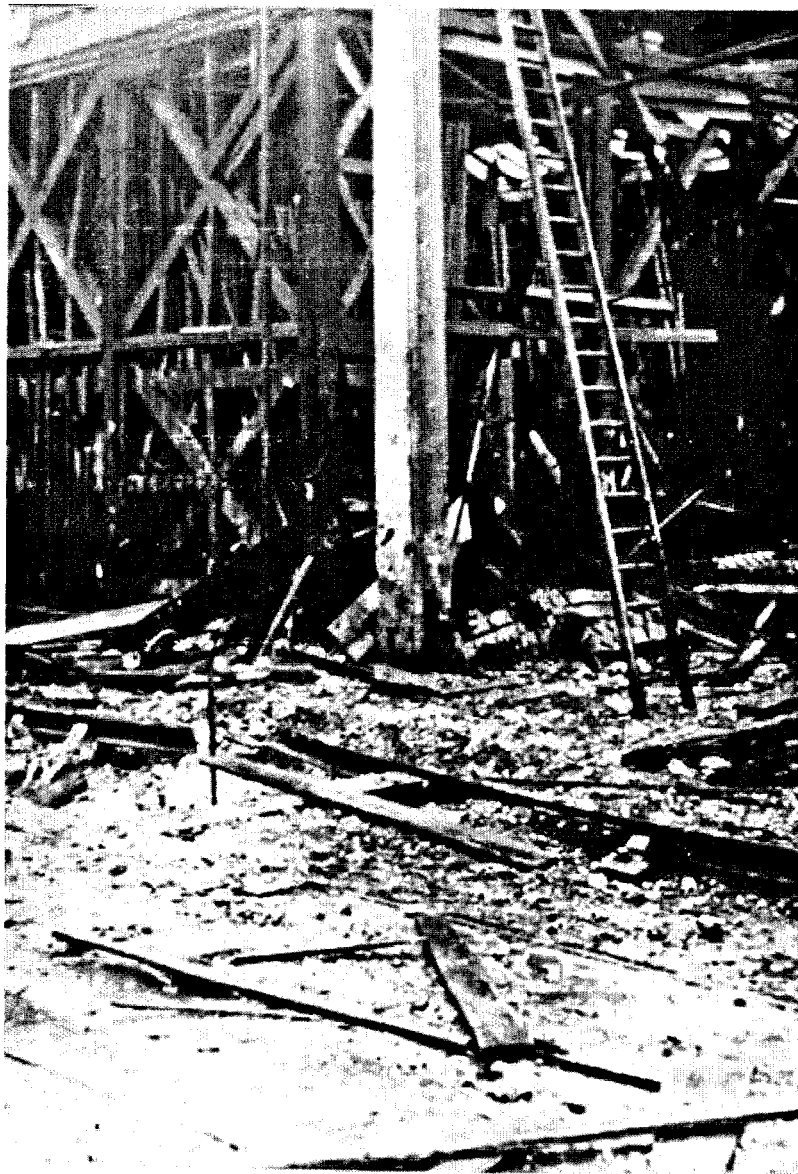
North East Corner of the Iron & Steel Store.

The North East corner of the Iron and Steel Store received damage. A number of windows were shattered along the West wall of the Smith's Shop and a quantity of glass in the roof broken.

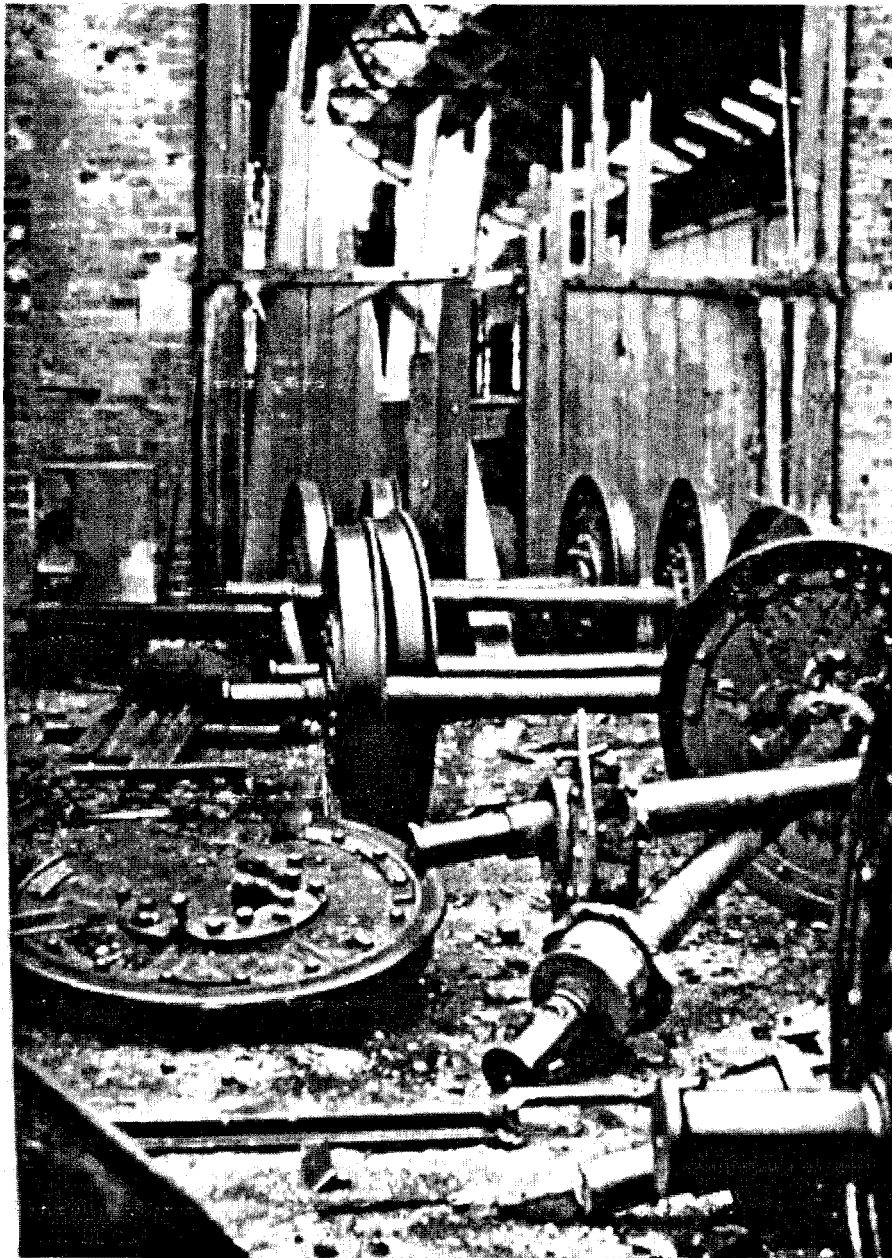
North End of the Brake Shop.

Brake Shop & Smithy.

The timber-built lean-to sheds containing the Smith's Shop blowers were blown in and 25 H.P. motor and starter of some of them received damage. Eight pairs of doors at the North end of the Lifting Shop were damaged, 6 pairs badly, but the building fabric appears to have stood up to it. The timber and iron building containing the two boshes for cleaning axleboxes received damage to the iron sheets and widows. A quantity of glass was shattered in the roof of the Lifting Shop and a number of widows at the South West corner of the Body Shop was blown in.

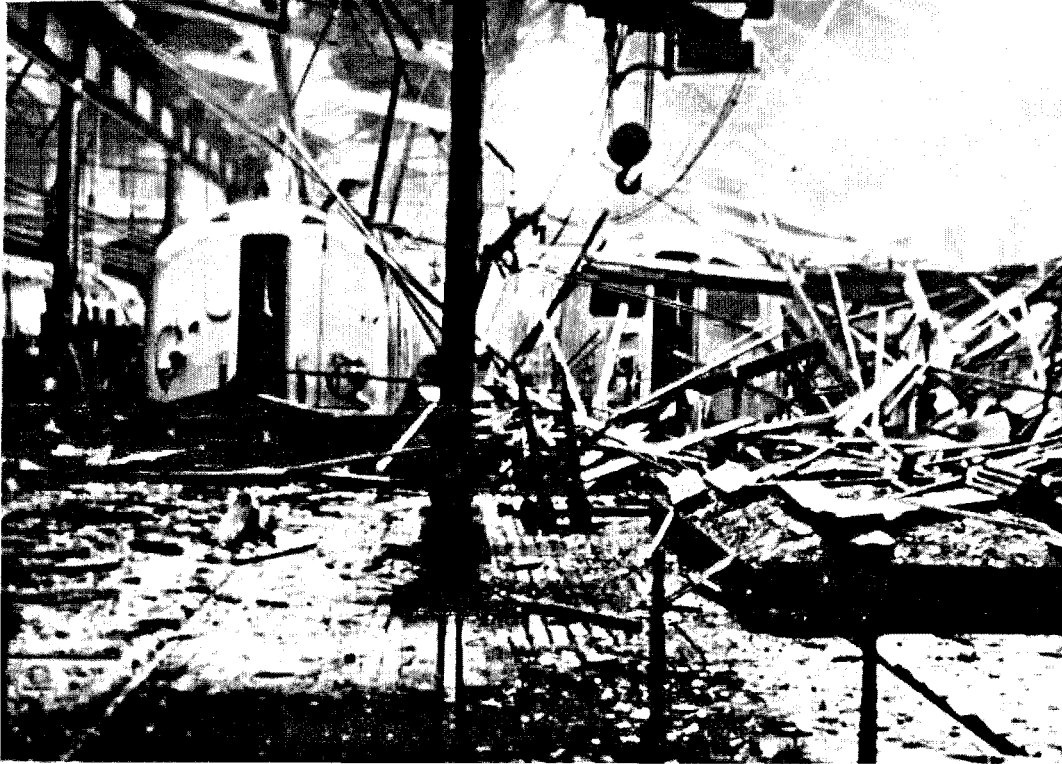
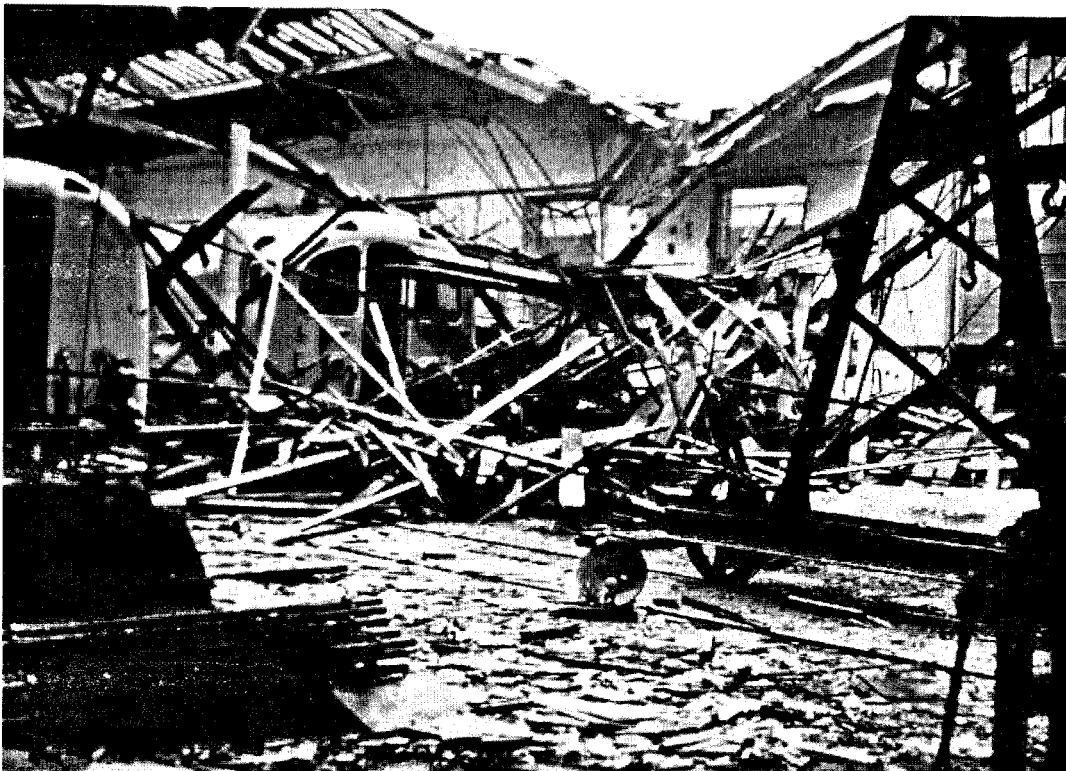
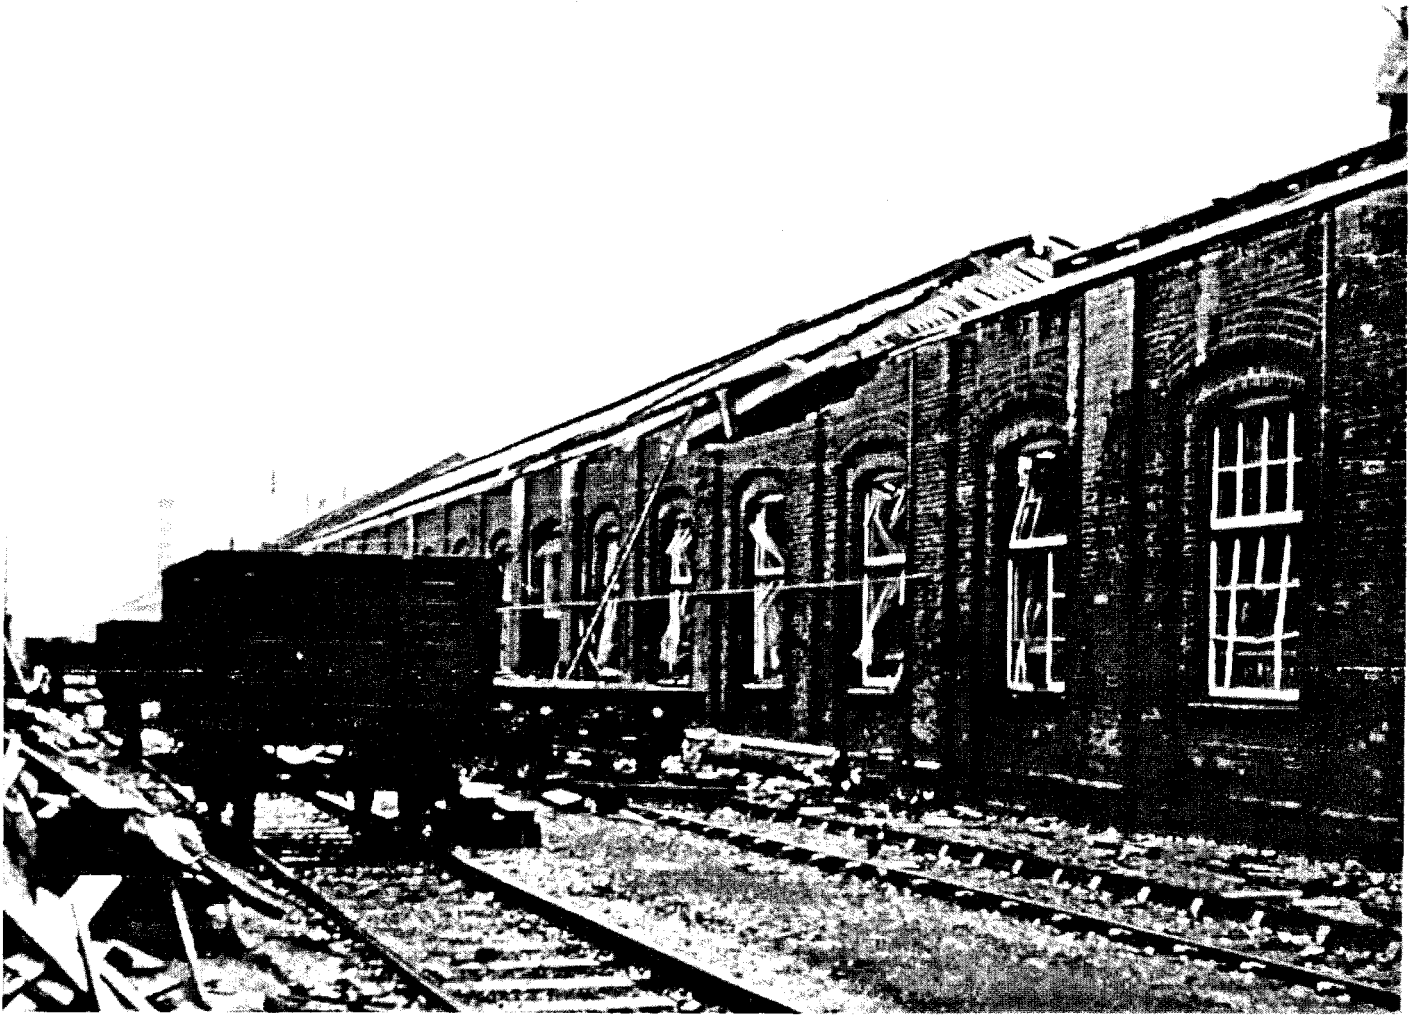
South West Corner of the Lifting Shop.

Lifting Shop.

This bomb fell in the South West corner of the Lifting Shop and it appeared to explode on contact with the roof. A portion of the roof about 35'0" in length in one bay fell in causing damage to Waterloo and City stock. A large quantity of glass was shattered in the Lifting Shop.

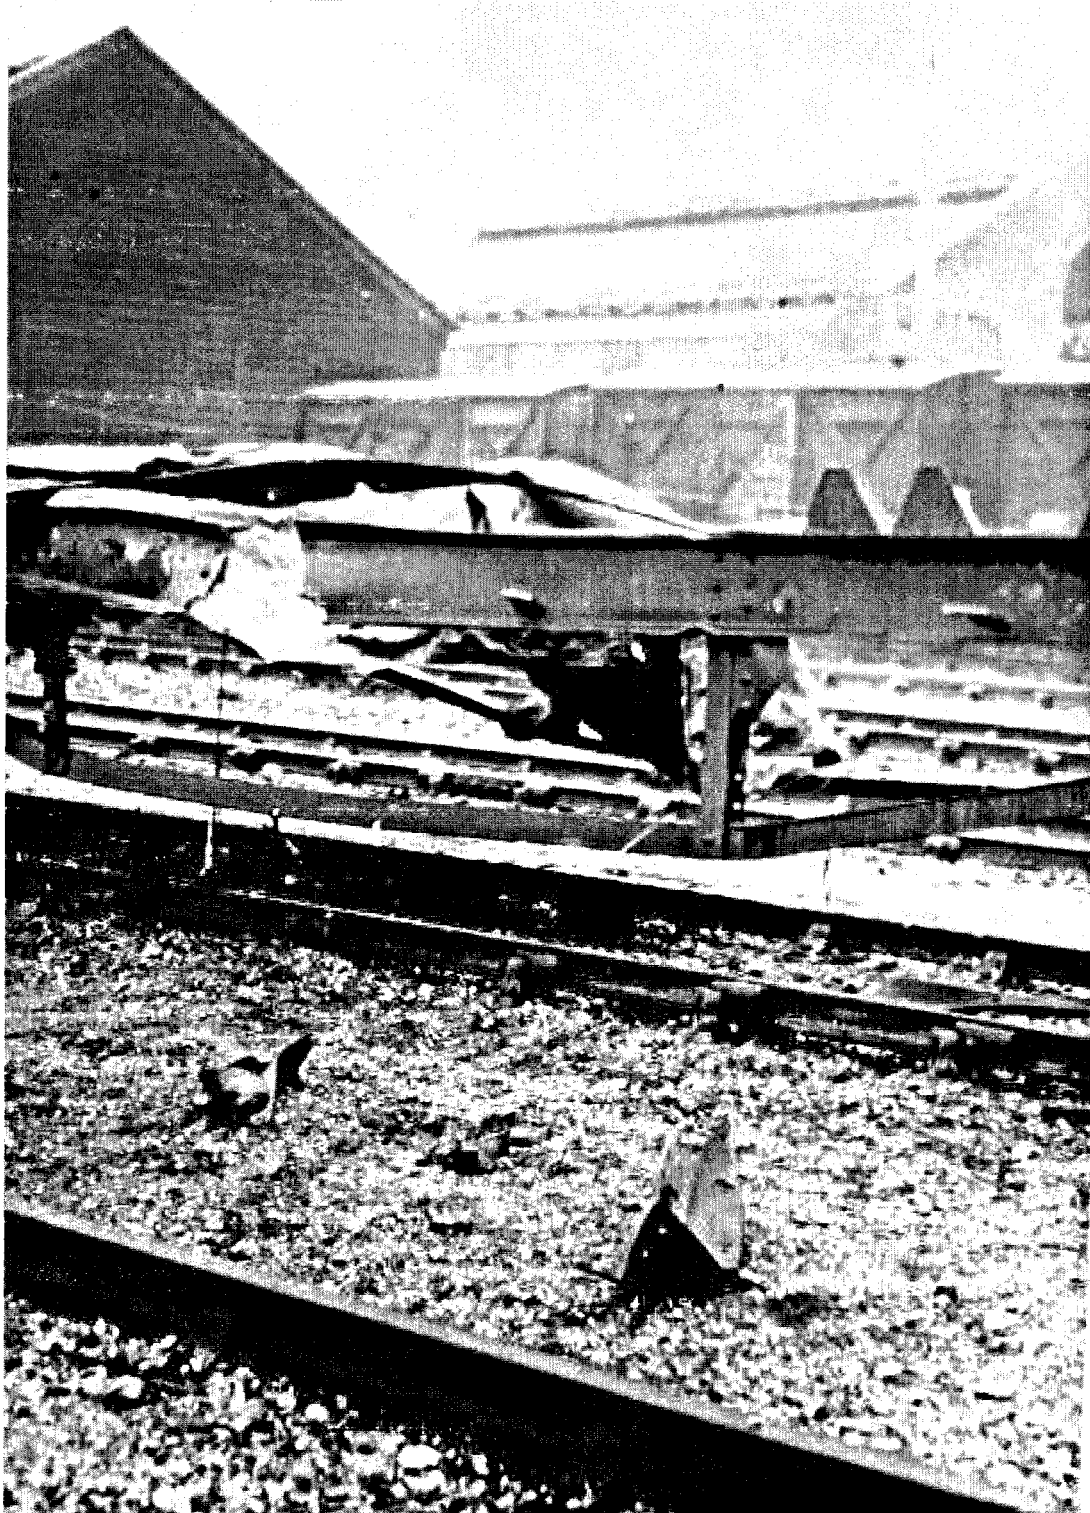
Underframe outside the Lifting Shop.

Yard South of Lifting Shop.

This bomb fell outside the South West corner of the Lifting Shop and landed in the centre of a new underframe. A hydraulic main was fractured by the explosion and the pipe broke a few days later.
